CAPITAL NEEDS ASSESSMENT

Mount Baker Lodge

Heather Meadows, Mount Baker Highway, Deming, WA 98244

January 12, 2022

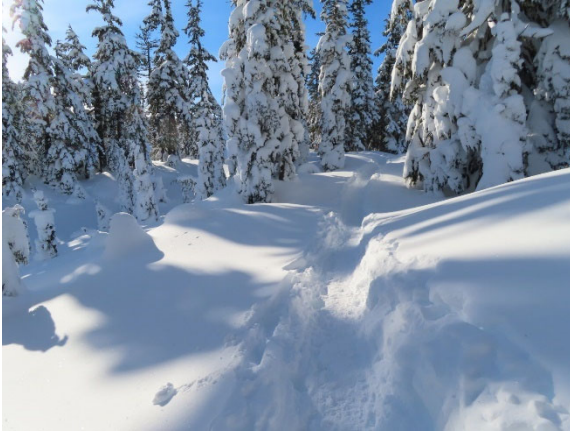
Trail Leading to Lodge

We understand that there is a desire to install a guard rail along the northwest side of the access road and trail, as there is a steep drop-off that is currently a safety hazard. We have budgeted for this guard rail installation in 2022 as a one-time expense.

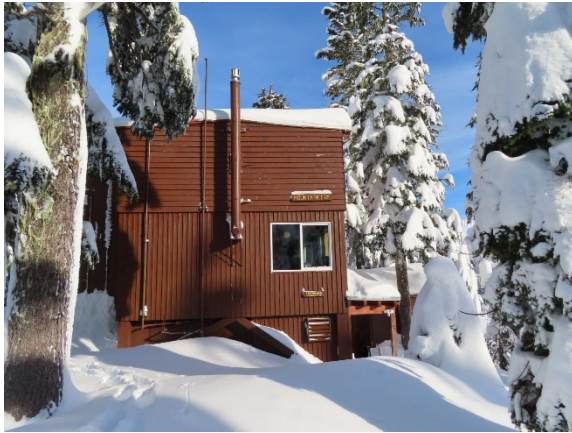
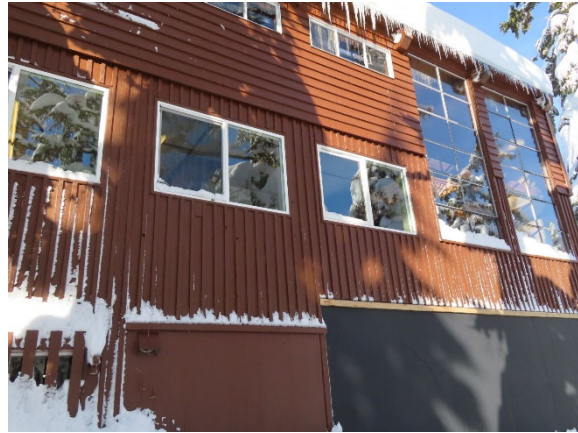
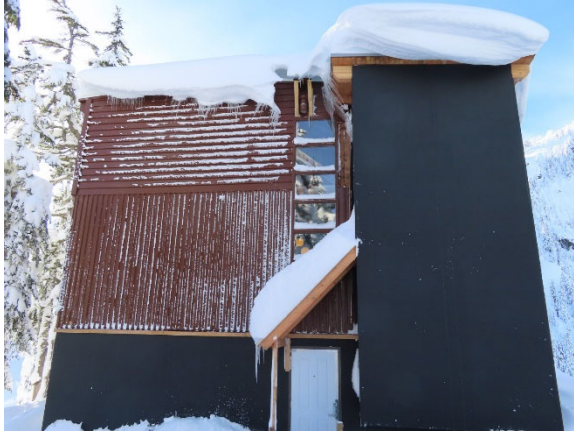
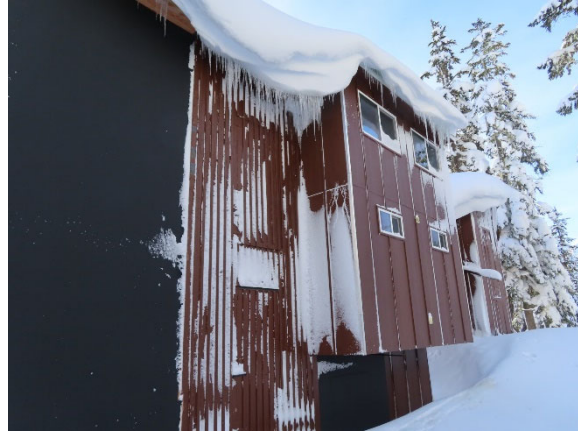
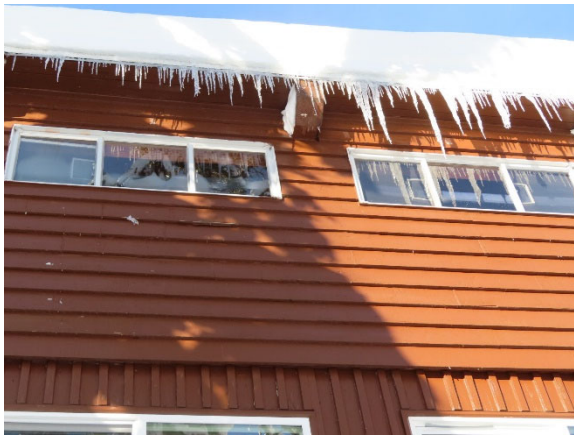
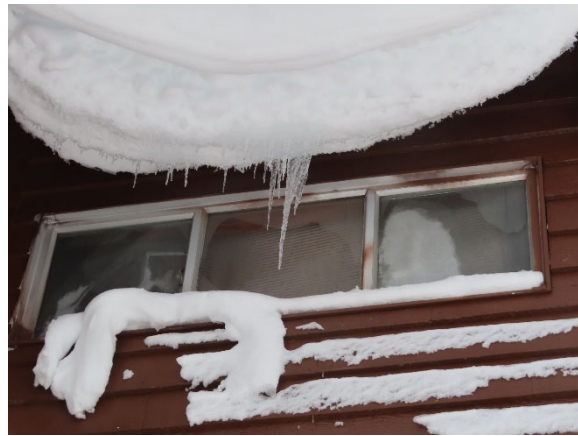
There is currently some rot damage of the siding near the bottom of the building as well as various areas of other damage likely caused by flickers (often mistaken for woodpeckers). In addition to total replacement of this siding and trim, we have included a spot siding and trim replacement line item on the same schedule as caulking and painting. Clearly, the siding and trim replacement should occur prior to re-caulking and re-painting.

This building should be repainted and re-caulked in 2022. Typically, a property should clean, caulk, and repaint this type of exterior siding and trim every 5 years. Often, the painting schedule is dictated by the south and west sides of the buildings, as that is typically hit by weather hardest in our area. Prior to repainting, the exteriors should be properly prepared for painting by scraping all loose paint off and spot replacing areas of siding and trim where necessary.

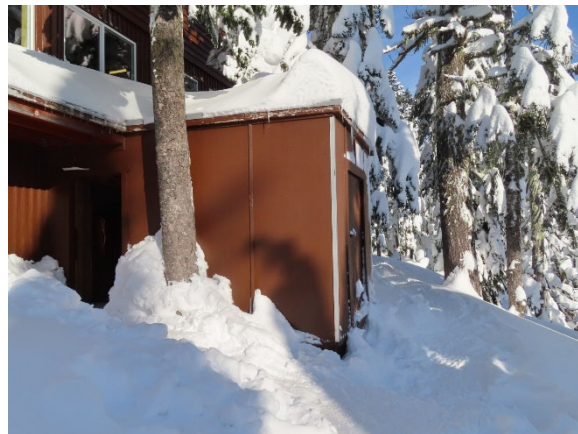
Exterior of Snow Tunnel

There is a snow tunnel at the main entrance to this building on the southeast side of the building. This snow tunnel is supported by pier blocks. We understand that there is a plan to install Diamond Pier hand driven piles beneath these pier blocks with in the next few years. For budgeting purposes, we have assumed that structural improvements to the snow tunnel will occur in 2025 at a budgetary cost of \$15,000.

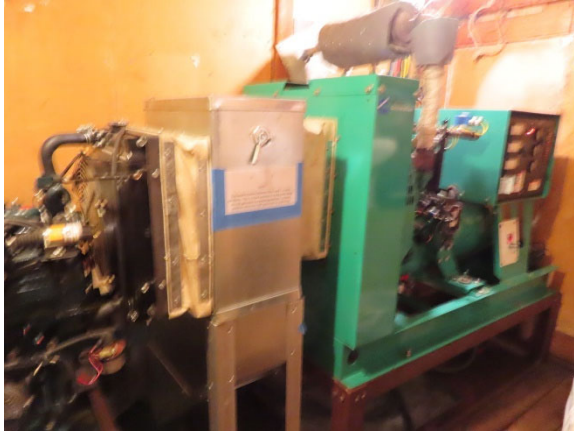
One of Two Generators

Electrical power is provided to this building via two propane-fueled generators that are supplied with fuel via a 1,000-gallon propane tank. We understand from the committee members that one generator is 9 kVA and was installed around 2011, while the other generator is 12 kVA and was installed around 2006. We were only able to directly view one of these generators and were not able to view the propane tank that we understand is approximately 20 years old. We have budgeted for replacement of the generators every 30 years and the propane tank every 40 years.

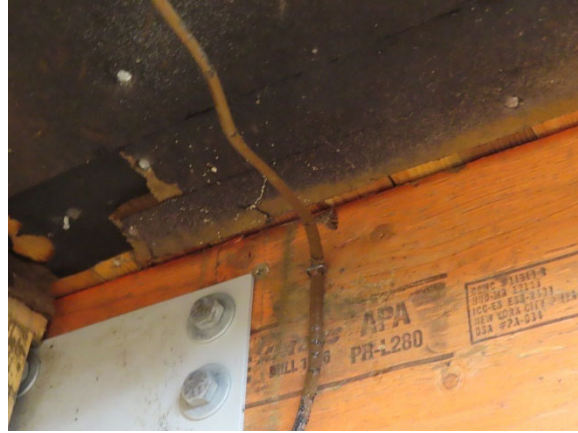
The electrical wiring in this building is a mix of modern Romex wiring and older 1950s vintage asphalt impregnated cloth wrapped wire, which we assume is original and is ungrounded. We recommend that all older wiring be replaced with modern wiring in conduit within the near future. While we have budgeted for this electrical upgrade in 2025, in reality it will be project based as each individual area of this lodge is renovated.

Older Wiring Visible in the Building

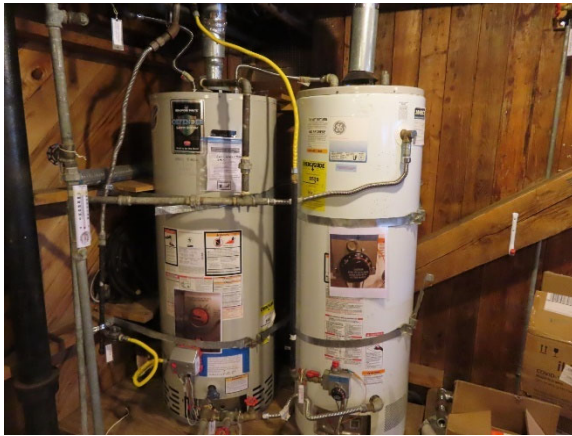
The domestic water in this building is heated by two 50-gallon water heaters that were manufactured in 2009 and 2017. Modern water heaters have a typical lifespan of 15 years. We understand that there is some desire to replace these water heaters with a combination of a tankless water heater and storage tank(s); however, this has yet to be determined, so we have merely budgeted for replacement of the current water heaters with like kind.

Two Gas Water Heaters

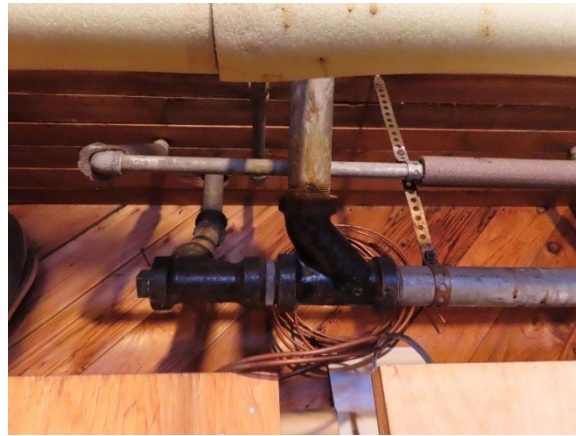
We understand that this building is served by a water supply pipe coming from Mount Baker Ski resort. This supply pipe is approximately ½ mile long and is assumed to be galvanized iron. We do not know what the diameter of this supply pipe is; however, it is likely 2-inch OD. This pipe is still effectively providing water to the building; however, we assume that this supply line will be replaced at the end of this study in 2042. We assume that this water supply pipe will be replaced with a 1-inch PVC or PEX water supply line.

We tested the majority of the plumbing fixtures on this property, and we believe that generally the supply piping and waste piping in these buildings is adequate at this time; however, the supply piping and waste piping will need to be replaced with modern piping at some point when corrosion limits the effectiveness of this piping. Therefore, we have simply budgeted for the supply piping and waste piping to be replaced at the end of this study in 2042. Typical plumbing maintenance and minor leak repair are anticipated with any property.

Typical Galvanized Iron Supply Piping and Waste Piping

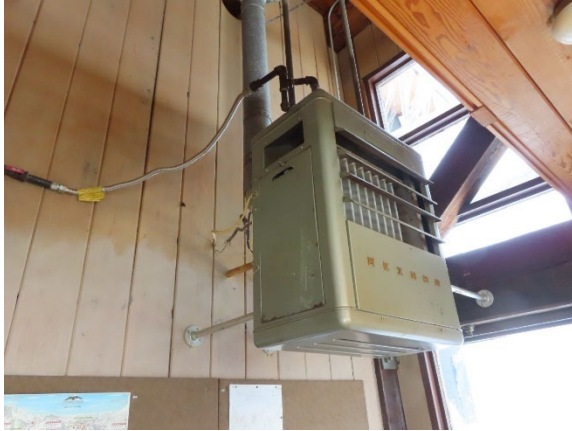
Hanging Reznor Furnace

The Reznor furnace is very old and will likely need to be replaced within the near future. We understand from the committee that they would like to install two whole house type furnaces (one on each side of the building), rather than replace the current Reznor furnace and the first-floor furnace. We have budgeted for a one-time cost of ductwork and infrastructure for these new furnaces and for the installation of gas furnaces in 2027. The typical life of a gas furnace is 25 years.

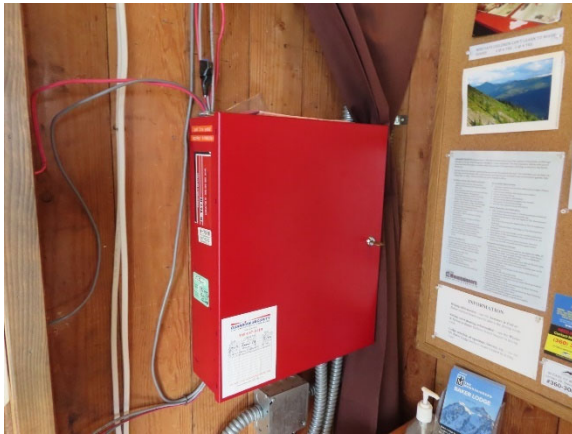
Fire Alarm Control Panel

This building has a central fire alarm system. The fire alarm system includes smoke detectors, pull stations, and audio-video annunciators (combination strobe and speaker). Manual pull stations are located at the exits, stairwell doors, and critical points within the building. Annunciator units are located in the occupied spaces, rooms, and the corridors. We have assumed that this system will be updated every 20 years.
